UNDERWATER FACILITIES

INSPECTIONS

ASSESSMENTS

**MARGINAL WHARF
TRIDENT REFIT FACILITY
BANGOR
BREMERTON, WASHINGTON**

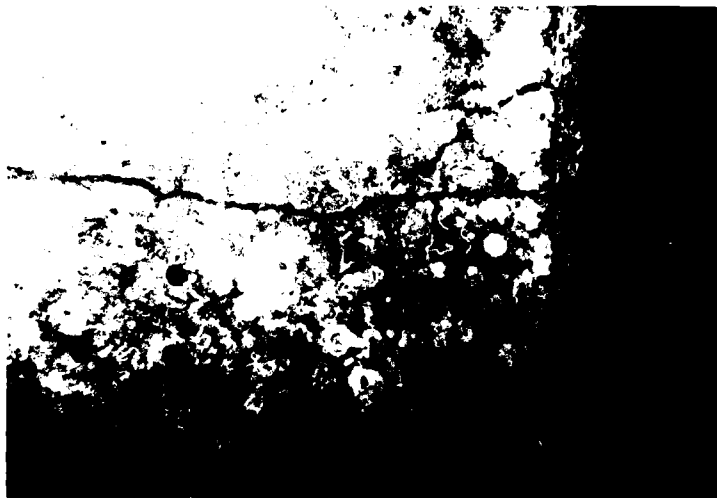
PHOTO NO. 1

The inspection found underwater damage at two piles. The first damaged pile was pile 115-A, which was found to have a double crack at an elevation of 17 feet 6 inches below mean sea level. This pile was also found to have loss of concrete and exposed reinforcing bars, at an elevation 20 feet below mean sea level (see photographs 1, 2 and 3). The second pile with damage was pile 138-A, which was fractured in two locations, causing the pile to be displaced horizontally at one point of damage approximately 20 inches. The concrete in the damaged section was fractured and has fallen away, exposing the reinforcing bars for a length of approximately 12 inches. This damaged area was within the tidal zone and both underwater and above water photographs were taken. (See photographs 4 and 5). It should be noted that both of these piles are located on the A row, or outer row, of the wharf, which is closest to the fender system. This damage appears to be caused by the impact of berthing vessels.

Pile 115A - Crack in pile at depth of 17'-6" below
mean sea level

| <u>Pile No.</u> | <u>Recommended Repair</u> |
|---|--|
| 115A | Cracks cleaned and high-strength epoxy injected. Pile jacket of five-foot length over epoxied crack. Concrete cover over topside exposed reinforcing bars. |

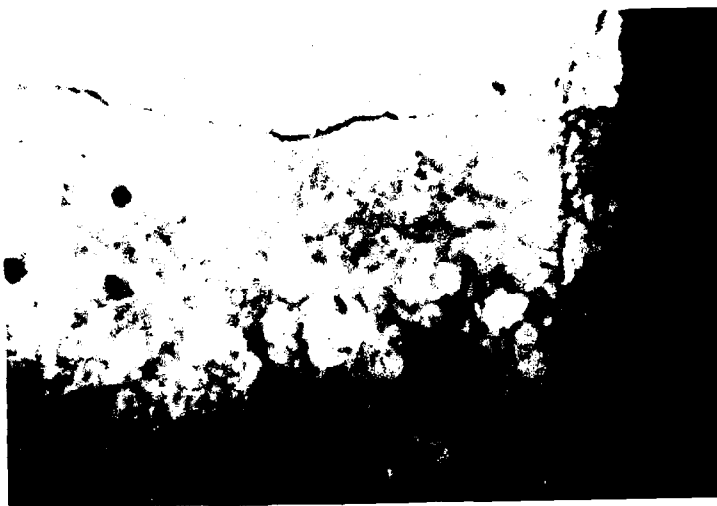
PHOTO NO. 2

Pile 115A - Crack in pile at depth of 17'-6" below
mean sea level
